# **Cars submerged in water: escaping problems**

## **Safety Study**

The Hague, 2003

## Transport Safety Board

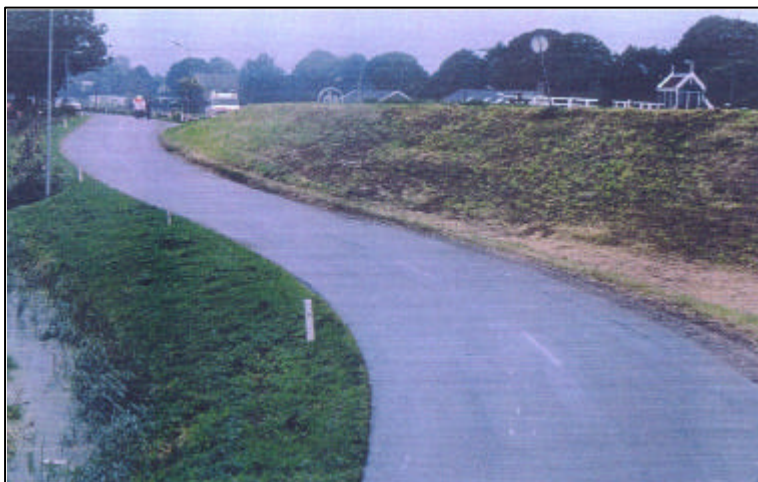
Photograph 1. The final bend at the scene of the accident. Source: Police.

The police car was driving at high speed on the road on the dike, and for unknown reasons left the road and ended up in the adjacent Oorgat. There were a number of witnesses to the accident. Initially, the car remained afloat. Several bystanders entered the water and attempted to open the front and back doors. They were unsuccessful in freeing the occupants. They had no life hammer at the outset. When a life hammer was made available, the car had already sunk below the surface of the water.

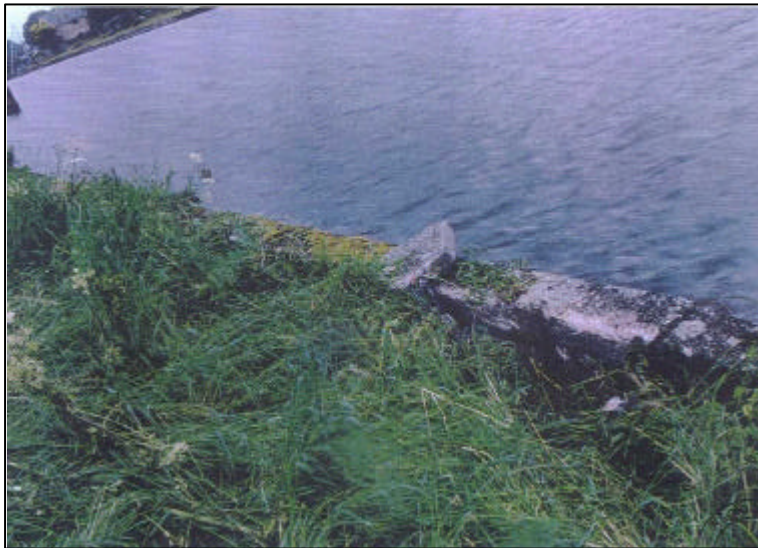
The boot and both left doors were locked. The windows of both left doors and the rear windshield were still intact. There was a small hole in the left upper corner of the front windshield. In order to recover the bodies of the victims, the divers removed the front windshield piece by piece, as well as the window of the left side door. Once the glass had been removed, the divers could still not raise the locks of the doors<sup>2</sup>.

Photograph 2: The bank of the Oorgat.  
Source: Police.

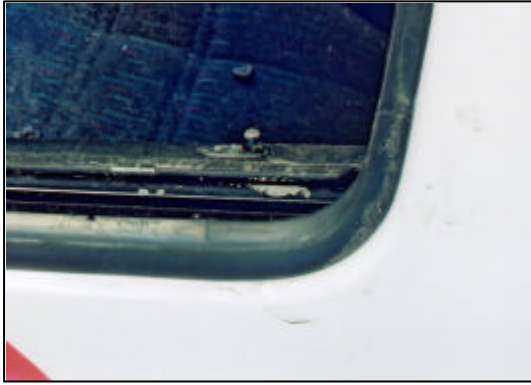
<sup>2</sup>source: reports of the TOD Amsterdam-Amstelland (pages 34). The divers' statements show that they were unable to open the doors. The TOD provided further information (5 June 2002, reference NG/10779) that stated that neither of the locking knobs on the left side doors could be raised. (The knob on the front left door had been broken off.)

Photograph 3a (left): Left side of the car, section of the front left door. The broken locking knob can be seen pulled up at the bottom left of the window  
Source: Police

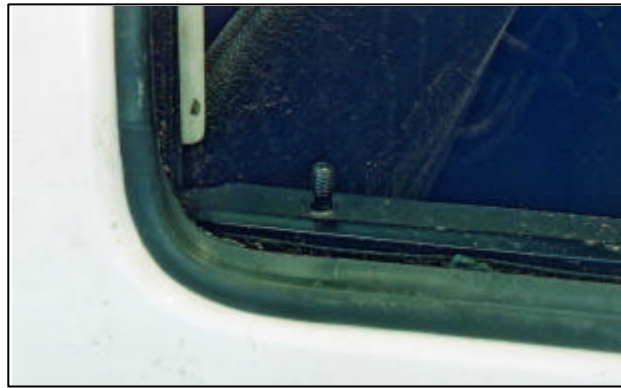
Photograph 3b (right): Left side of the vehicle, section of the left front door. The unbroken locking knob can be seen in its entirety.  
Source: Police

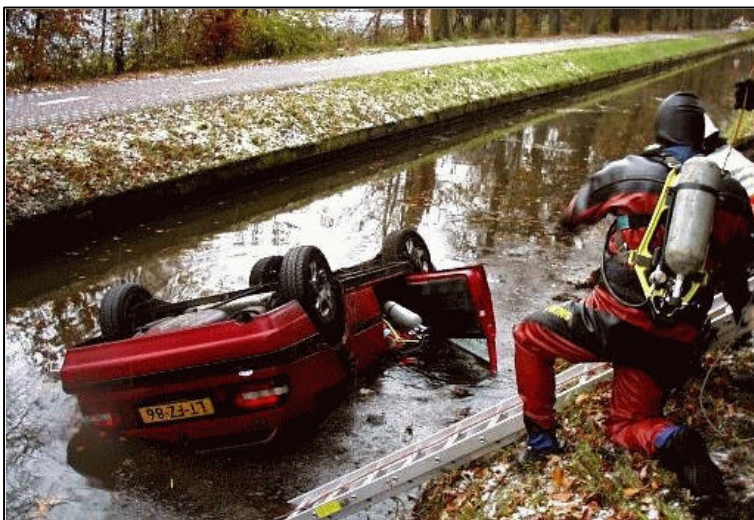
Photograph 4 Example of a car on its roof and partially submerged. Source: ANP.

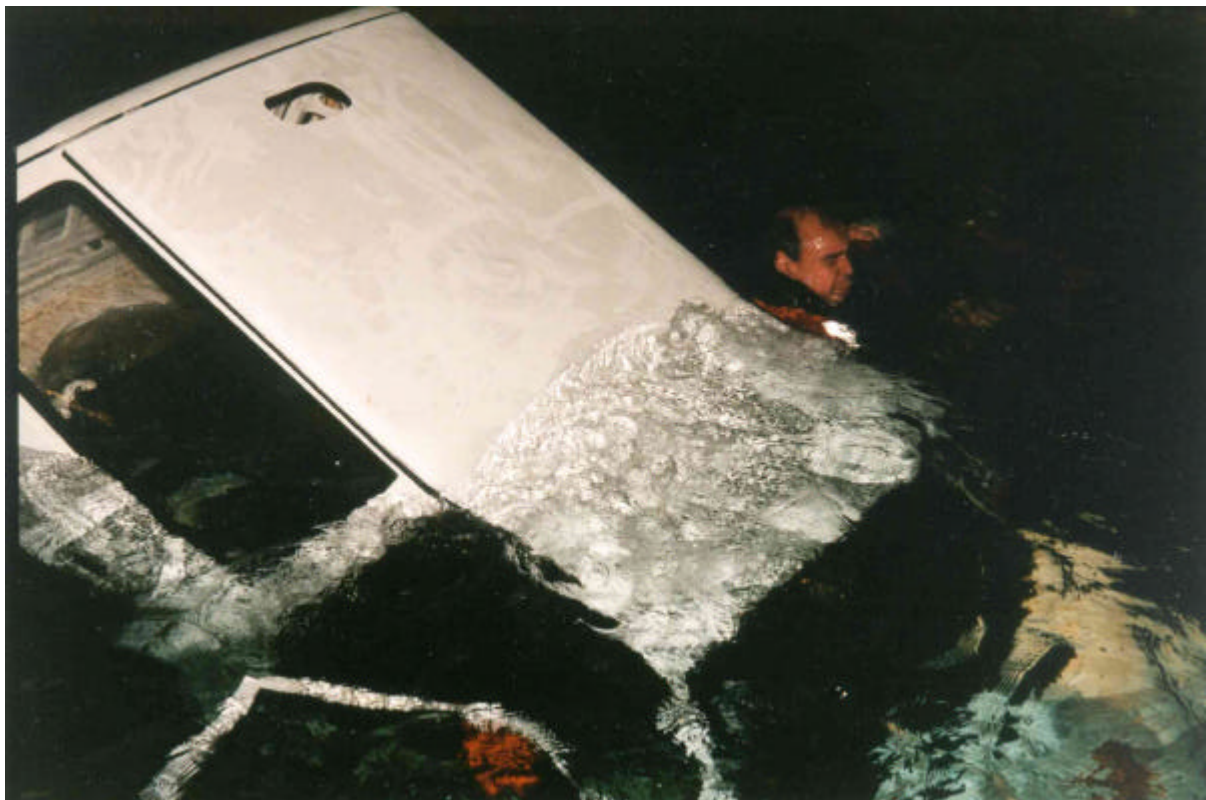
Photograph 5: Submerged vehicle. Source: Ricas
