AN INVESTIGATION OF THE POTENTIAL SAFETY BENEFITS OF VEHICLE BACKUP PROXIMITY SENSORS

Viliam Glazduri

Transport Canada

Paper Number 05-0408

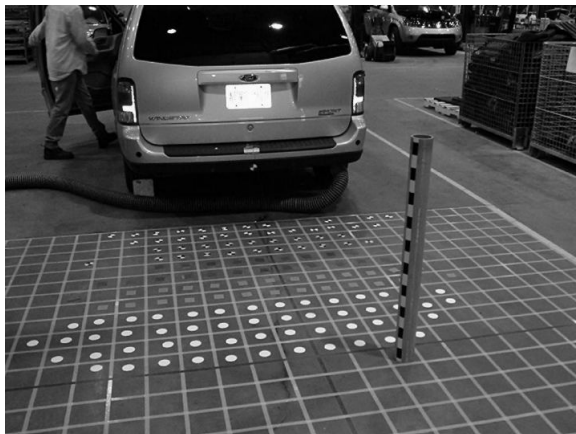
The detection zones were mapped on a 3.60 m x 3.60 m test surface. The test surface was divided into grids. Each cell was 15 cm x 15 cm in size. The test object was a 9 cm diameter and 100 cm tall PVC tube (Figure 1).

Figure 1.
Detection zone test surface and test object.

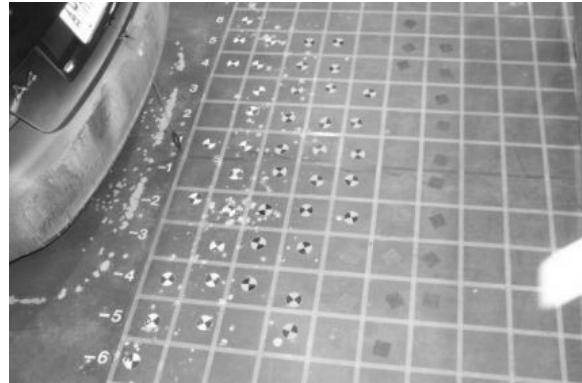
With the vehicle stationary, the test cylinder was moved manually and placed in each cell. Once a continuous detection signal from the system was

received, the cell was marked corresponding to the frequency of the signal.

Figure 2.
Grid cell markings

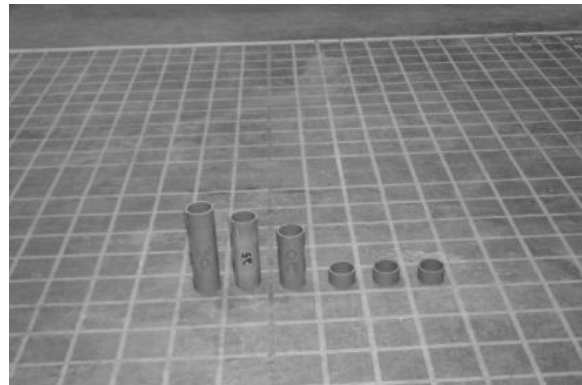
In addition to the 100 cm test tube, tubes of different heights, ranging from 5 to 95 cm, in 5 cm increments, were used to map the bottom edge of the detection zone.

Figure 4.
Tubes used to map lower edge of detection zone

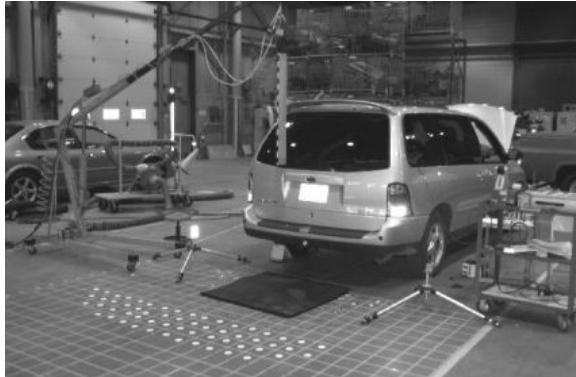
The time delay between the appearance of the test object in the detection zone and the initiation of the audio signal was recorded on a chart recorder that was connected to an optical sensor and a microphone. The 100 cm test cylinder was suspended from above the detection zone just behind the rear bumper. The top of the detection zone was marked with the optical sensor. As the cylinder entered the top of the detection zone it triggered the optical sensor. The reaction time of the sensor system was the difference between this event and the audible signal given by the sensor. This test was repeated ten times for each system.

The response time was taken as the average of the 10 runs.

Figure 5.
Response time test set up

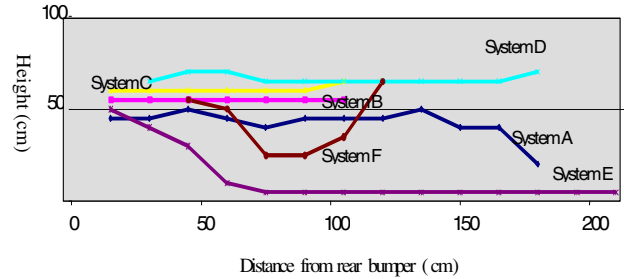
Figure 8 shows a plot of the bottom edge of the detection zones measured along the central longitudinal axis. The sensors did not detect the area below the lines. All the profiles began at bumper height. System D was from a pickup truck, which had a high bumper height. The OEM systems tended to remain at bumper height level right to the end except system A, which dipped toward the ground near the end of its detection distance. The profiles of the two aftermarket systems exhibited different shapes. System E displayed the lowest cut-off. The bottom edge of the detection zone was very close to the ground at 75 cm behind the bumper. System F’s profile dipped towards the rear but then went up again at the very end of the detection zone.

Figure 8.
Average height of the lower edge of detection zones

Another aspect to consider is the detection height. In the analysis it is assumed that the object behind the vehicle has sufficient height so that the bottom of the sensor detection zone does not pass over it. Five of the six sensor systems tested had a minimum detection zone heights ranging from 45 to 65 cm. Sensor system E had a detection zone very close to ground level for most of its depth. Paine and Henderson recommended a minimum detection height of 60 cm in their analysis. They reasoned that the driver would have visual contact of a standing child of this height through the rear window. They also recognized that there would be some instances where a detection height of 60 cm may be insufficient (such as a child crawling or bending down) and detection would not be possible but reasoned that this was a fair trade-off against nuisance alarms. Indeed, it is very likely that sensor system E would display more false alarms than the other systems for objects close to the ground such as curbs. Nevertheless, this trade-off detection zone height still leaves the potential for the above scenario to exist thereby further reducing real world effectiveness of these sensor systems.

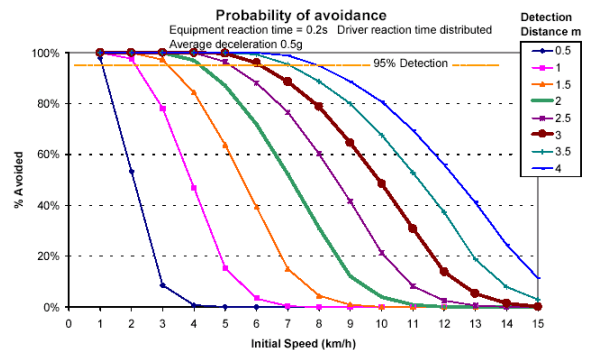
Figure 10.
Percentage of collisions avoided as derived by Paine and Henderson⁷ for various vehicle speeds and detection distances

Figure 10 shows that effectiveness is highly sensitive to vehicle speed. For example, a 1 km/h increase in vehicle speed can reduce the effectiveness by as much as 20%.

Applying the same analysis to the maximum detection distance and response time results obtained for the systems tested yielded the following estimates. The maximum speeds at which the systems achieve 25%, 50% and 95% avoidance levels are tabulated below.
